Manhole Inspection Summary

Manhole # S31EE_022MH

Insp Date: **1/25/07 7:19 AM**

Location Address: **PRESTON ST**

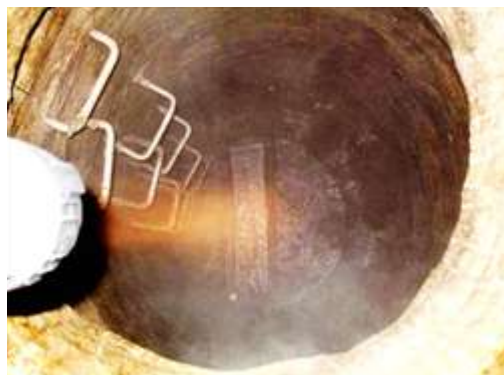
Top View

Bench ☒ Exists Material: **Unknown** ☐ Parged ☒ **Debris** (not Condition related)

Bench debris.

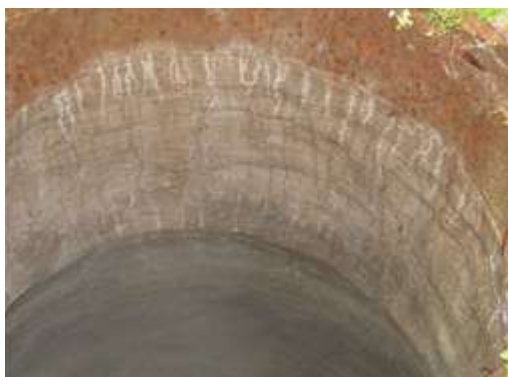
Defect

Infiltration: ☐ None ☒ **Joint** ☐ Cracks ☐ Mortar ☐ Roots ☒ **Wall**

Infiltration: ☐ None ☐ Joint ☐ Cracks ☐ Mortar ☐ Roots ☒ **Wall**

Corbel and Barrel infiltration.

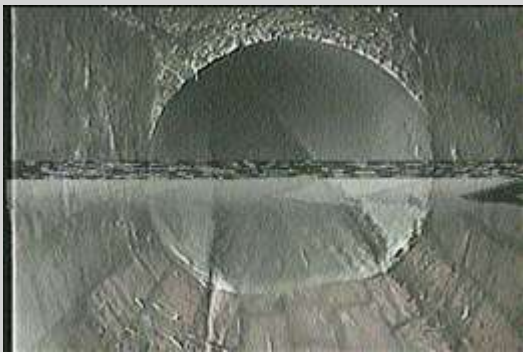
16 in. Circular Gravity Sewer Pipe Out @ 12 O'Clock

Rod and Bar (Angled)

Invert Depth: **17.99** (ft.) Flow Characteristics: **Fast**

Infiltration: **None** Pipe Seal Cond: **Unknown**

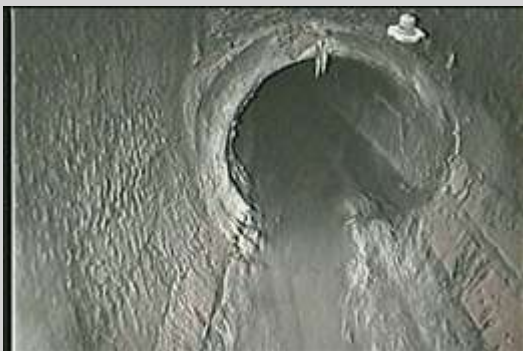
12 in. Circular Gravity Sewer Pipe In @ 6 O'Clock

Rod and Bar (Angled)

Invert Depth: **17.60** (ft.) Flow Characteristics: **Fast**

Infiltration: **None** Pipe Seal Cond: **Unknown**
